Chapter 4.1 | Flow Path

Before addressing potential technical causes of the blowout, the Chief Counsel's team presents its findings regarding the flow path of hydrocarbons from the well. These findings form an important background to the subsequent technical analyses. Because different kinds of well failures cause hydrocarbons to flow through different paths, these findings can help to refine theories about what caused the blowout.

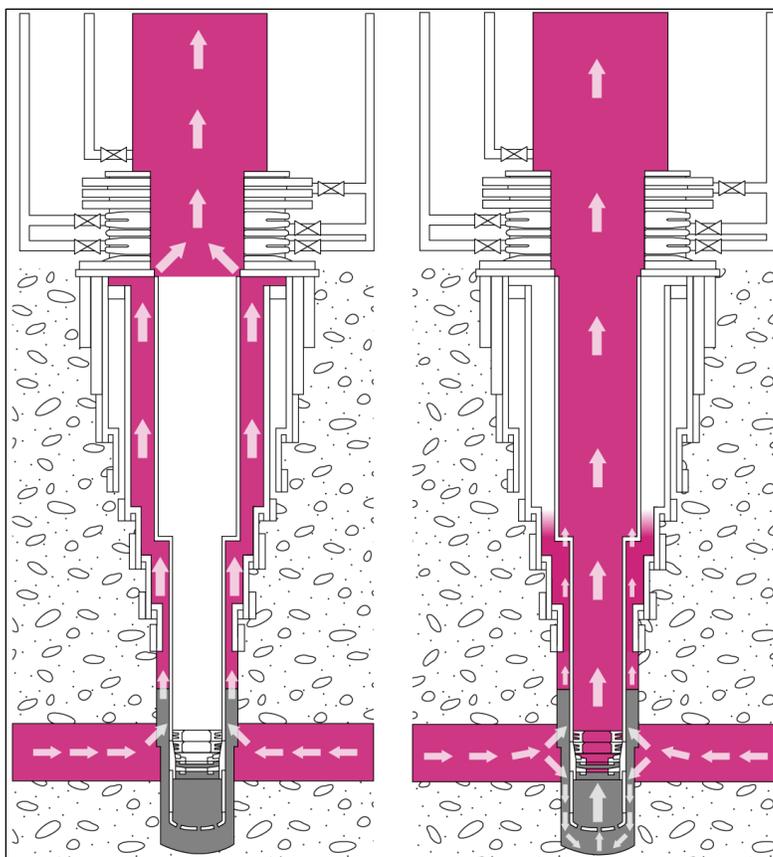
Figure 4.1.1. Possible flow paths for hydrocarbons.

Hydrocarbons can reach the surface by traveling up the annulus and through the seal assembly (left). Hydrocarbons can also enter and migrate up the inside of the production casing, through a number of possible flow paths (right).

The Chief Counsel's team finds that hydrocarbons came to the surface by traveling through the inside of the production casing, as seen on the right side of Figure 4.1.1. It is almost certain that hydrocarbons entered the production casing because of a failure of the shoe track cement. However, the Chief Counsel's team cannot entirely rule out the possibility that hydrocarbons may have entered the production casing from the annulus through a breach in the production casing somewhere near the bottom of the casing.

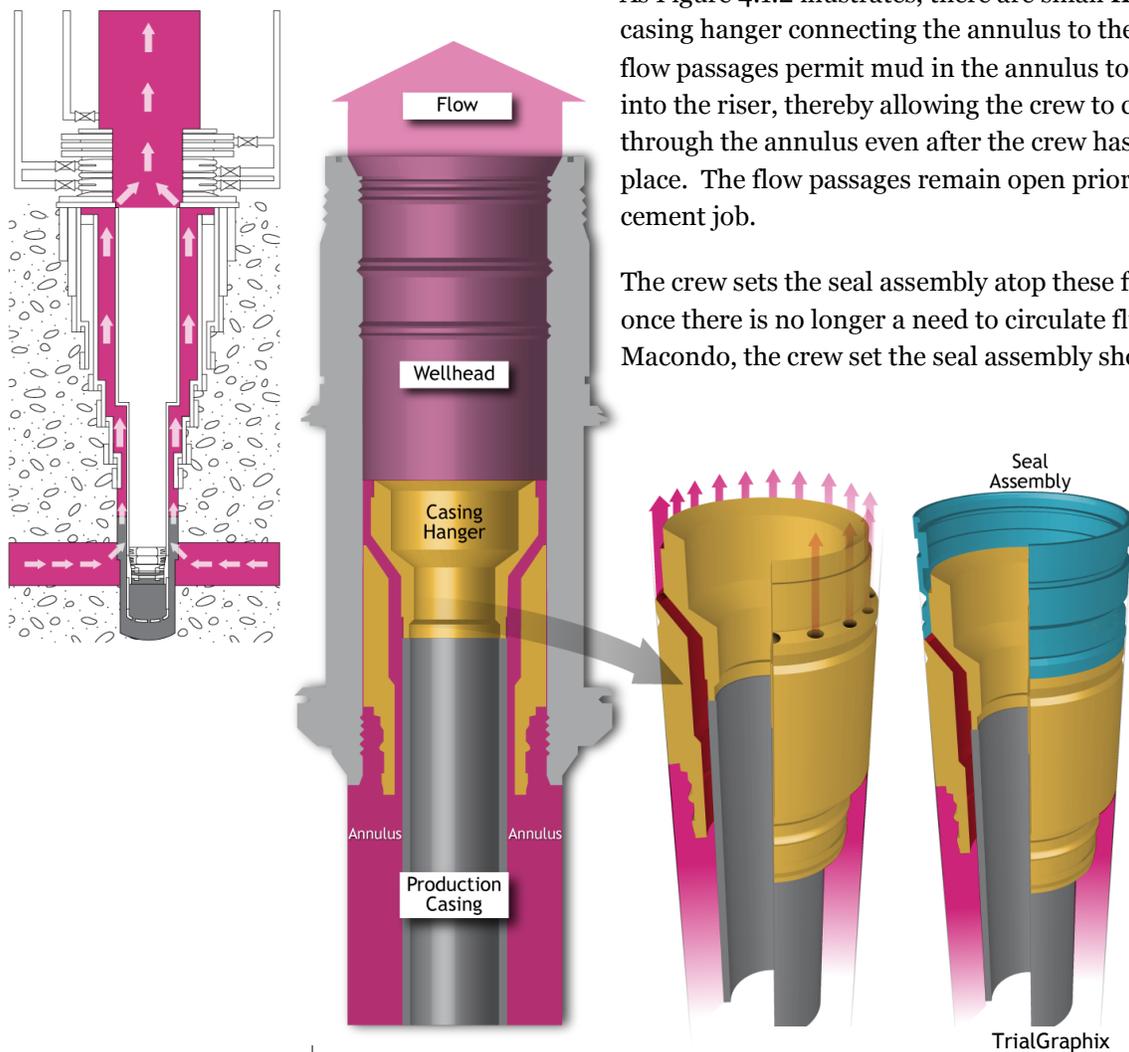
Figure 4.1.2.
Flow through the seal assembly.

As Figure 4.1.2 illustrates, there are small **flow passages** through the casing hanger connecting the annulus to the inside of the wellhead.³ The flow passages permit mud in the annulus to flow into the wellhead and up into the riser, thereby allowing the crew to circulate drilling fluids through the annulus even after the crew has set the production casing in place. The flow passages remain open prior to and during the final cement job.

First, there could have been a leak through the flow passages. This might have occurred because debris obstructed the seal area during the setting process, the seal failed to expand and set properly, or the seal dislodged after it was set.⁴

Second, because the lockdown sleeve had not yet been set at the time of the blowout, pressure and forces from the well below could have lifted the casing hanger up and out of place in the wellhead. Several forces could have generated such uplift, alone or in combination:

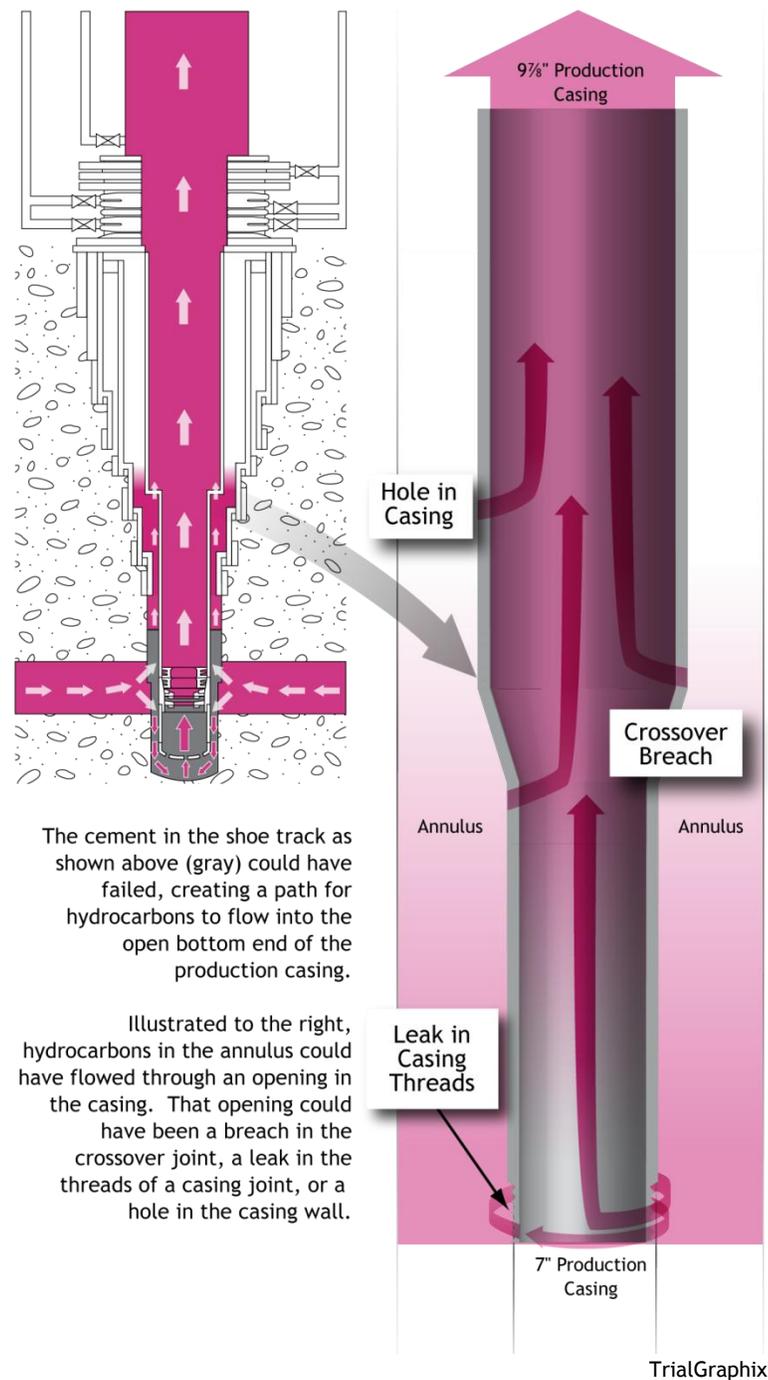
Figure 4.1.3. Flow up the production casing.

Second, hydrocarbons in the annulus could have flowed into the production casing through an opening in the casing. That opening could have been a breach in the 9⁷/₈-inch × 7-inch tapered crossover joint,⁸ a leak in the threads of a casing joint,⁹ or a hole in the casing wall, as illustrated in Figure 4.1.3.

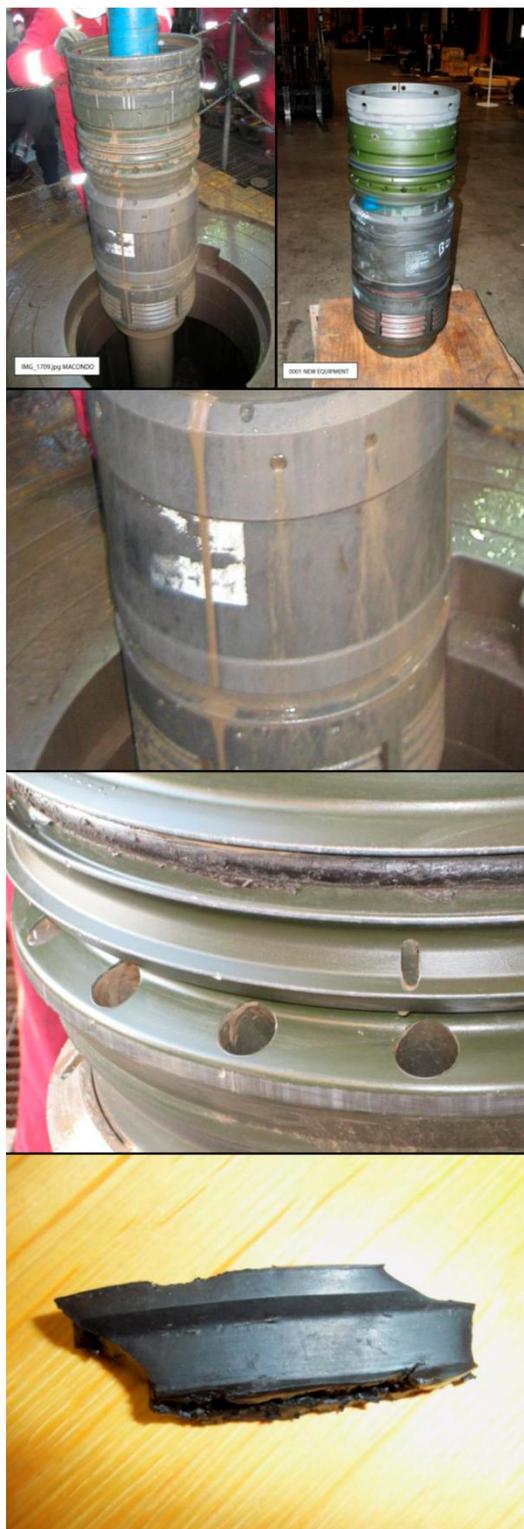
On October 13, BP recovered the production casing hanger and seal assembly from the Macondo wellhead.⁴⁰ Neither piece of equipment showed any signs of damage in locations where annular flow would have caused serious erosion. Instead, the relevant areas were totally undamaged.

- Figure 4.1.4. Exterior of the Macondo production casing hanger and seal assembly. The outside surfaces of the Macondo casing hanger and seal assembly show no damage (left). They have no erosion-induced channels. Instead, they resemble the condition of brand-new equipment (right).

- The white square placed on the casing hanger before it was set remains. If hydrocarbons had flowed past that area, they almost certainly would have removed this mark.⁴¹

- The 18 flow passages in the casing hanger show no signs of erosion.⁴² If hydrocarbons had flowed through those passages at the velocities estimated for this blowout, they likely would have eroded and enlarged the holes.⁴³

- The rubber elastomeric element of the seal assembly (removed post-incident and circulated out into the shaker⁴⁴) still retains its original shape, including a protrusion that one would expect to have been eroded away by annular hydrocarbon flow.⁴⁵

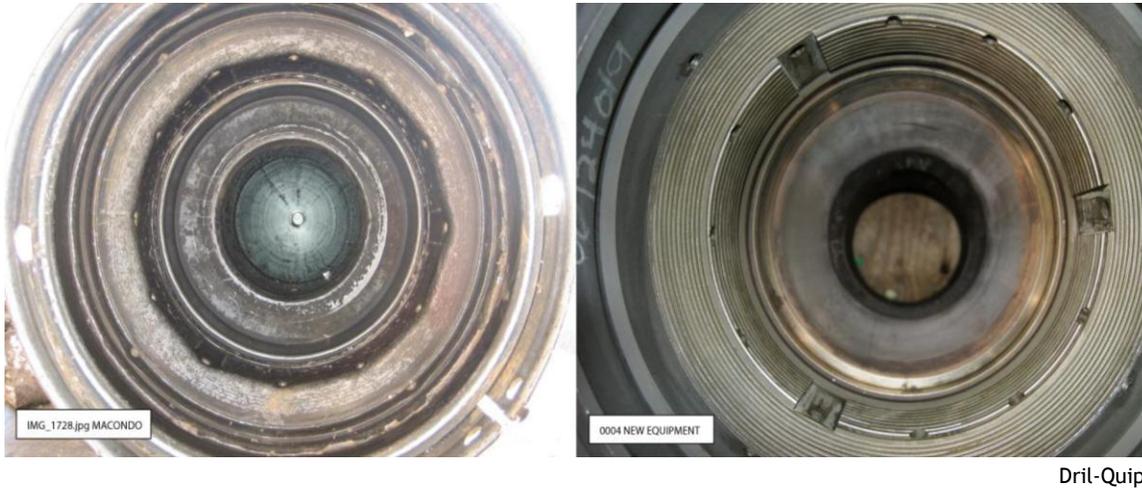
Figure 4.1.5. Interior of the Macondo production casing hanger compared to new equipment.

By contrast, the interior of the BOP⁴⁶ (through which hydrocarbons definitely flowed) showed serious erosion, as did the interior of the casing hanger, seen in Figure 4.1.5.⁴⁷

This is strong evidence that hydrocarbons progressed up the inside of the production casing, not up the annulus past the casing hanger and through the seal assembly.⁴⁸

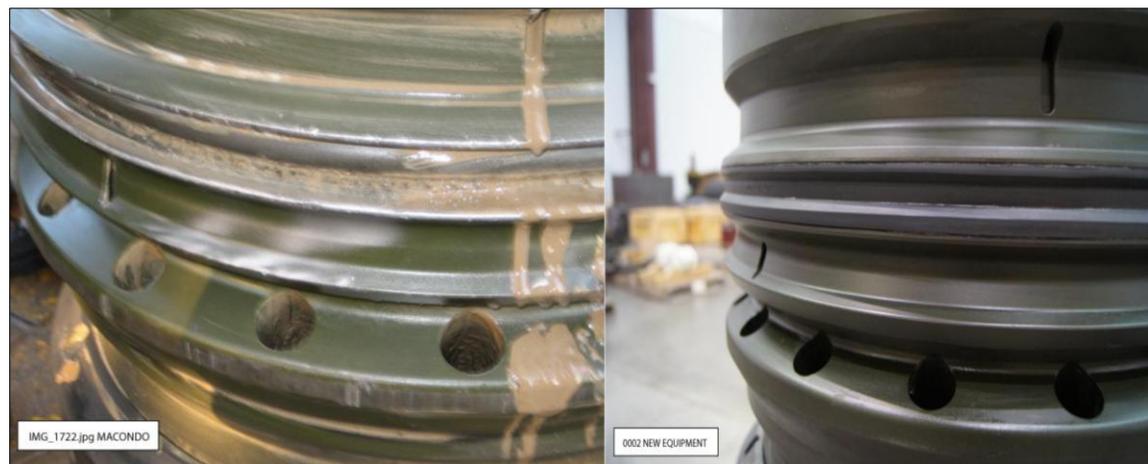
Figure 4.1.6. Undamaged metal edges of the casing hanger and seal assembly.

The casing hanger and seal assembly contain a series of circular metal lips (as shown in Figure 4.1.6) that protrude and fit inside a corresponding profile on the inside of the wellhead housing. The parts fit together very precisely to create a metal-to-metal seal. If the casing hanger had lifted out of place, it would have caused significant damage to these metal lips. Post-blowout photographs of the casing hanger and seal assembly show no such wear.⁴⁹

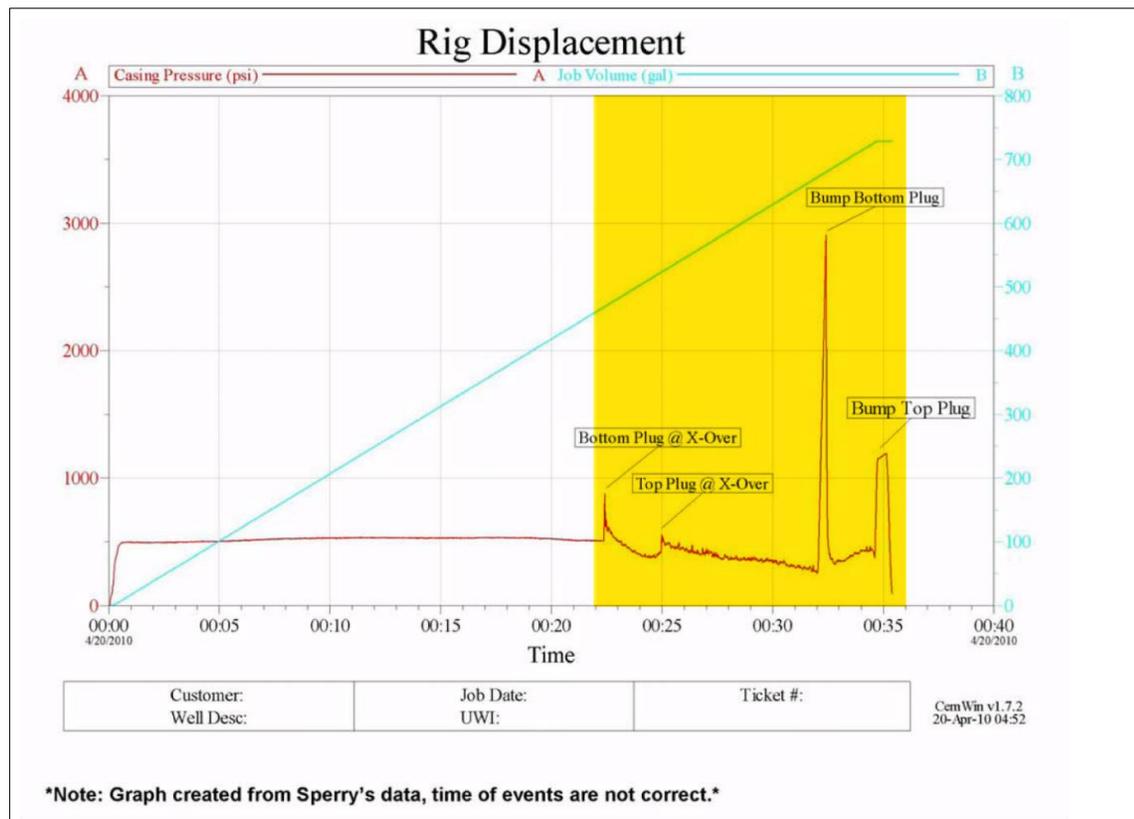
Figure 4.1.7. Halliburton post-cement-job report.

Despite the evidence described above, Halliburton argues that “hydrocarbons may have already been present in or even flowing into the annulus before the production casing cement job was complete.”⁶¹ The company bases its hypothesis on the “discernable drop in surface pressure at the conclusion of the cement job” that occurred on April 20 (illustrated in Figure 4.1.7).⁶²

First, the observed fluctuation in surface pressure can be explained by the wellbore geometry at Macondo.⁶³ Macondo had a **tapered** production casing string—9⁷/₈ inches from wellhead to 12,488 feet below sea level, tapering to 7 inches from 12,488 feet below sea level to the bottom of the casing. In wells with a tapered production casing (and hence a tapered annulus), “each discrete volume of fluid will grow in column height as it travels down the well [past the crossover joint] and shrink as it comes up the well [past the crossover joint].”⁶⁴ As a result, the hydrostatic pressure differential between the casing and the annulus will change over the course of the cement job (as it did at Macondo).

Second, the drop in surface pressure did not appear particularly anomalous at the time. In fact, Halliburton's own pre-job cementing model predicted that pressure would decrease by some amount.⁶⁵ The Chief Counsel's team has not identified any evidence to suggest that rig personnel monitoring the Macondo cement job thought that the pressures they were seeing were abnormal.⁶⁶

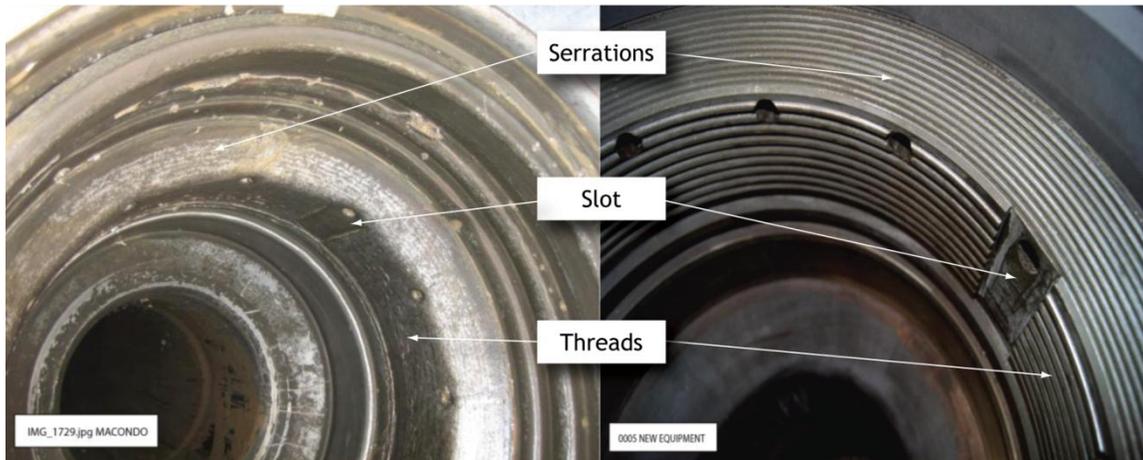
Figure 4.1.8. Erosion of the inside of the casing hanger.

Post-blowout inspection of the production casing hanger and seal assembly retrieved from the Macondo well shows severe erosion on the inside of the casing hanger (shown in the left-side photo in Figure 4.1.8). Serrations near the top of the casing hanger—normally 1/8-inch deep—are almost completely abraded away.⁶⁸ Threads that normally run around the inside of the casing hanger are flattened.⁶⁹ The slot that normally interrupts the threads—1/4-inch deep when new—appears as an almost nonexistent indentation.⁷⁰ These observations all suggest that hydrocarbons came up through the production casing.

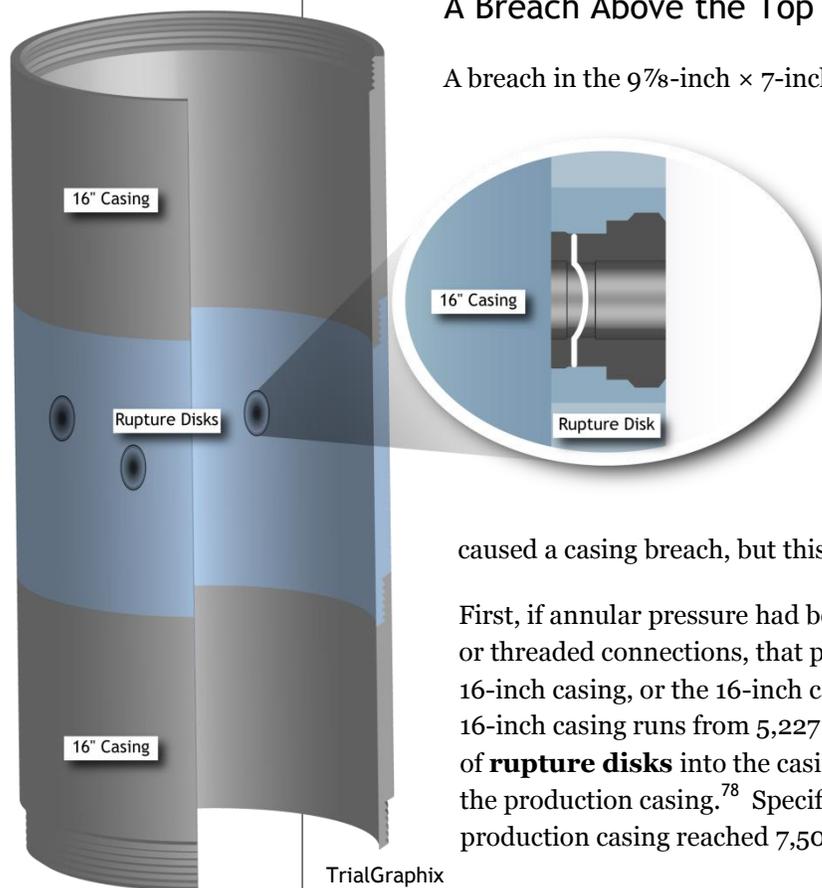
Figure 4.1.9. 16-inch casing and rupture disks.

First, if annular pressure had been sufficient to cause a breach in the production casing or threaded connections, that pressure should first have caused rupture disks in the 16-inch casing, or the 16-inch casing itself, to burst (shown in Figure 4.1.9). The 16-inch casing runs from 5,227 to 11,585 feet below sea level.⁷⁷ BP installed three sets of **rupture disks** into the casing wall. The rupture disks were designed to fail before the production casing.⁷⁸ Specifically, if pressure between the 16-inch casing and the production casing reached 7,500 psi, the rupture disks should have burst outward.⁷⁹

This pressure is, by design, less than the 11,140 psi that the production casing and its threaded connections are designed to withstand.⁸⁰ Even if the rupture disks did not function as designed, the 16-inch casing probably would have failed in some manner once pressures significantly exceeded 6,920 psi.⁸¹ But it appears that neither the rupture disks nor the 16-inch casing failed. [Chapter 4.2](#) discusses this issue in more detail.
