## Chapter 4.6 | Negative Pressure Test

The Chief Counsel's team finds that the failure to properly conduct and interpret the negative pressure test was a major contributing factor to the blowout.

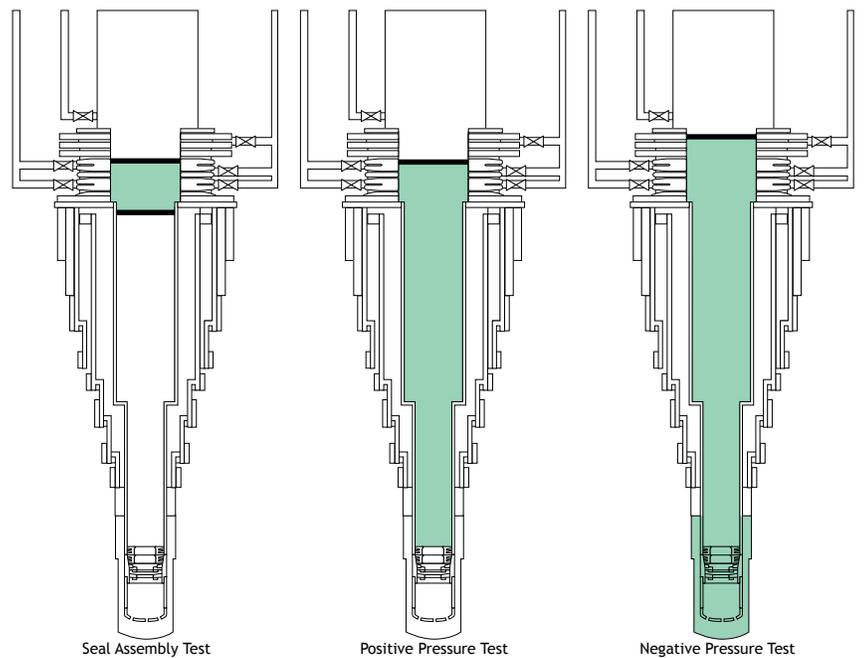
**Figure 4.6.1. Well integrity tests.**

The rig crew conducted three pressure tests as part of the temporary abandonment procedure to verify the integrity of the well. From left to right: the seal assembly test, the positive pressure test, and the negative pressure test. Test regions are shown in green.

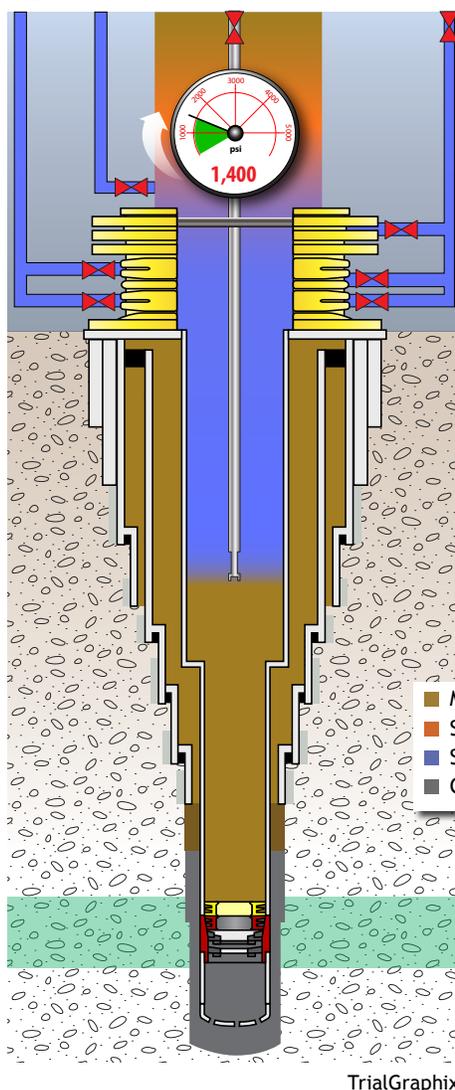
**Figure 4.6.7. First test failure.**

All parties now agree that this 1,400 psi pressure reading indicated that the well had failed the negative pressure test and that the cement job would not prevent hydrocarbons in the pay zones from entering the well.<sup>7</sup> The 1,400 psi pressure was the pressure of the hydrocarbon-bearing pay zone that was not properly sealed off by the primary cement.

During the first negative pressure test, the crew repeatedly bled the drill pipe pressure down to 0 psi. However, more fluids bled than expected, and the drill pipe pressure repeatedly increased. After the last bleed, the drill pipe pressure rose from 0 to 1,400 psi, a clear failure.

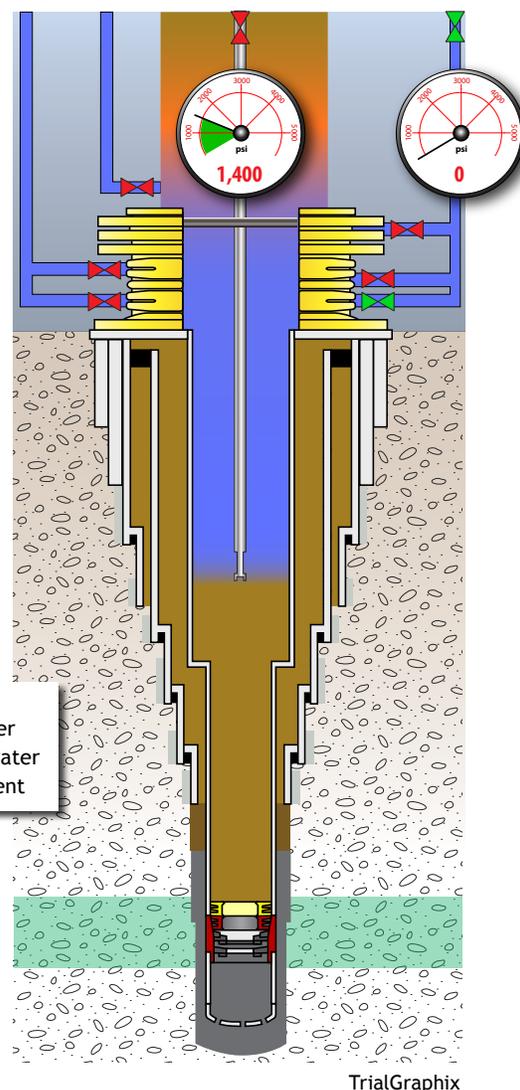
**Figure 4.6.8. Second test failure.**

During the second negative pressure test, the crew bled off the pressure in the kill line, rather than the drill pipe. The crew observed no excessive flow or pressure buildup on the kill line. The well site leaders and rig crew decided this was a successful test. But they had never accounted for the pressure on the drill pipe, which remained at 1,400 psi throughout the second test.

*The well site leaders and rig crew never adequately accounted for that elevated pressure in the drill pipe.*

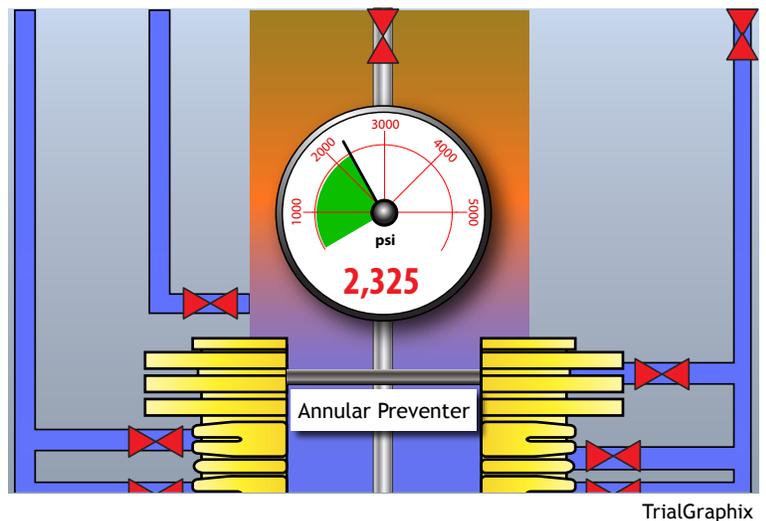
**Figure 4.6.11. 4:53 p.m.**

The crew closed the annular preventer around the drill pipe. The drill pipe pressure was approximately 700 psi higher than should have been expected, a sign that some spacer may have remained beneath the BOP.

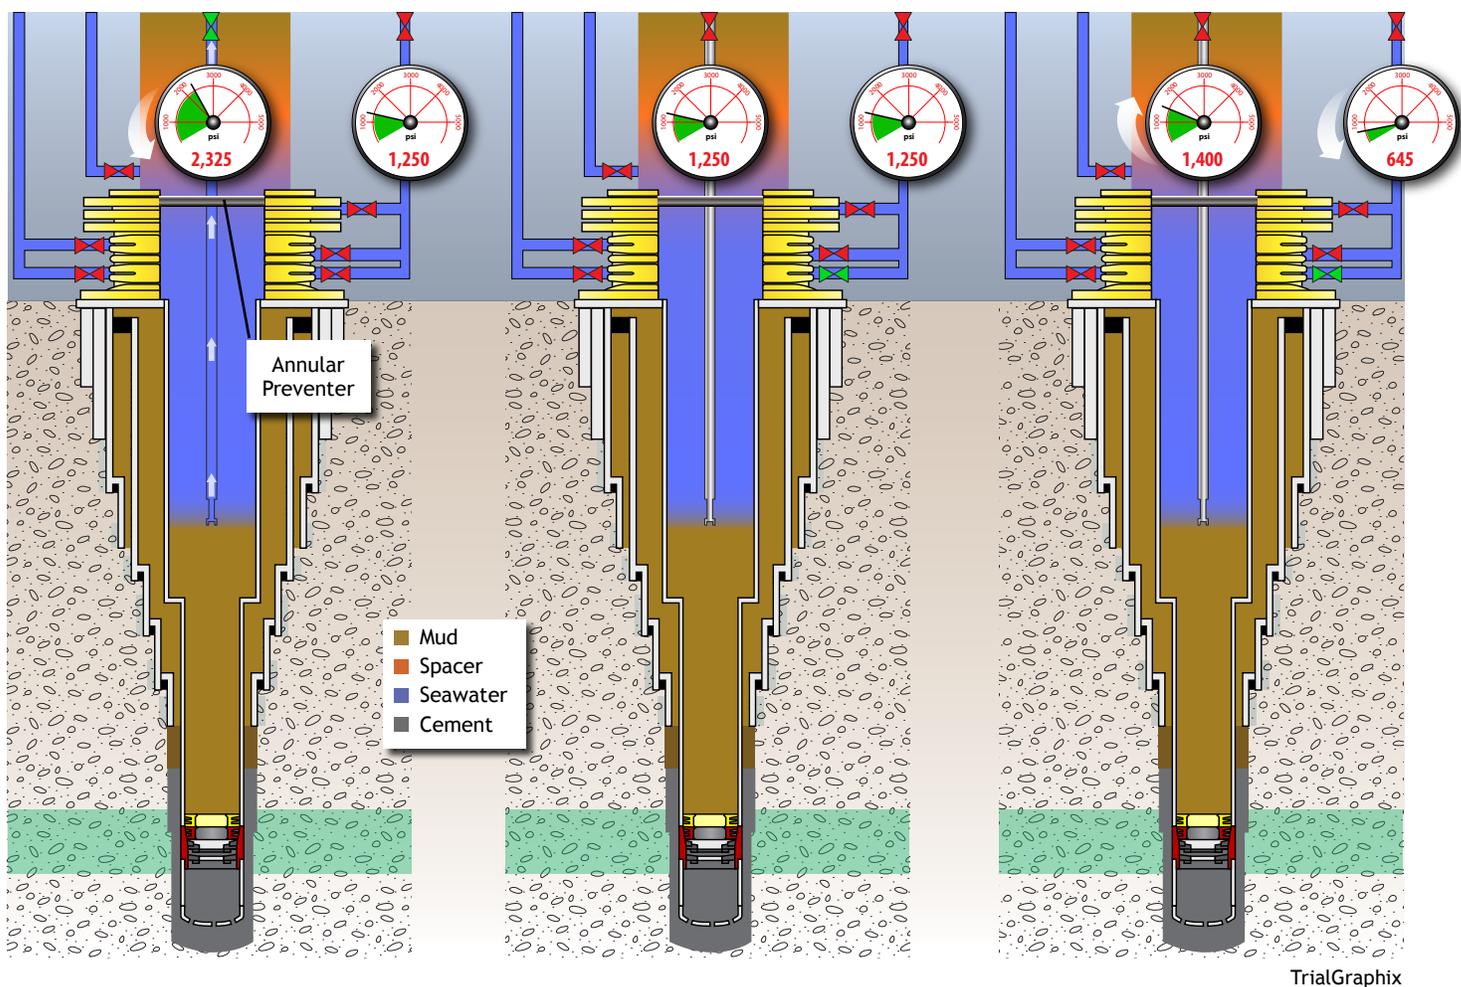
Figure 4.6.12. 4:55 p.m.

After the annular preventer was closed (left) the crew bled down the pressure in the drill pipe to equalize its pressure with the pressure in the kill line. Because both the drill pipe and the kill line go to the same vessel, when the valve connecting the kill line to the BOP is opened, the pressures should remain equal (middle). Instead, when the valve was opened, the pressures diverged (right).

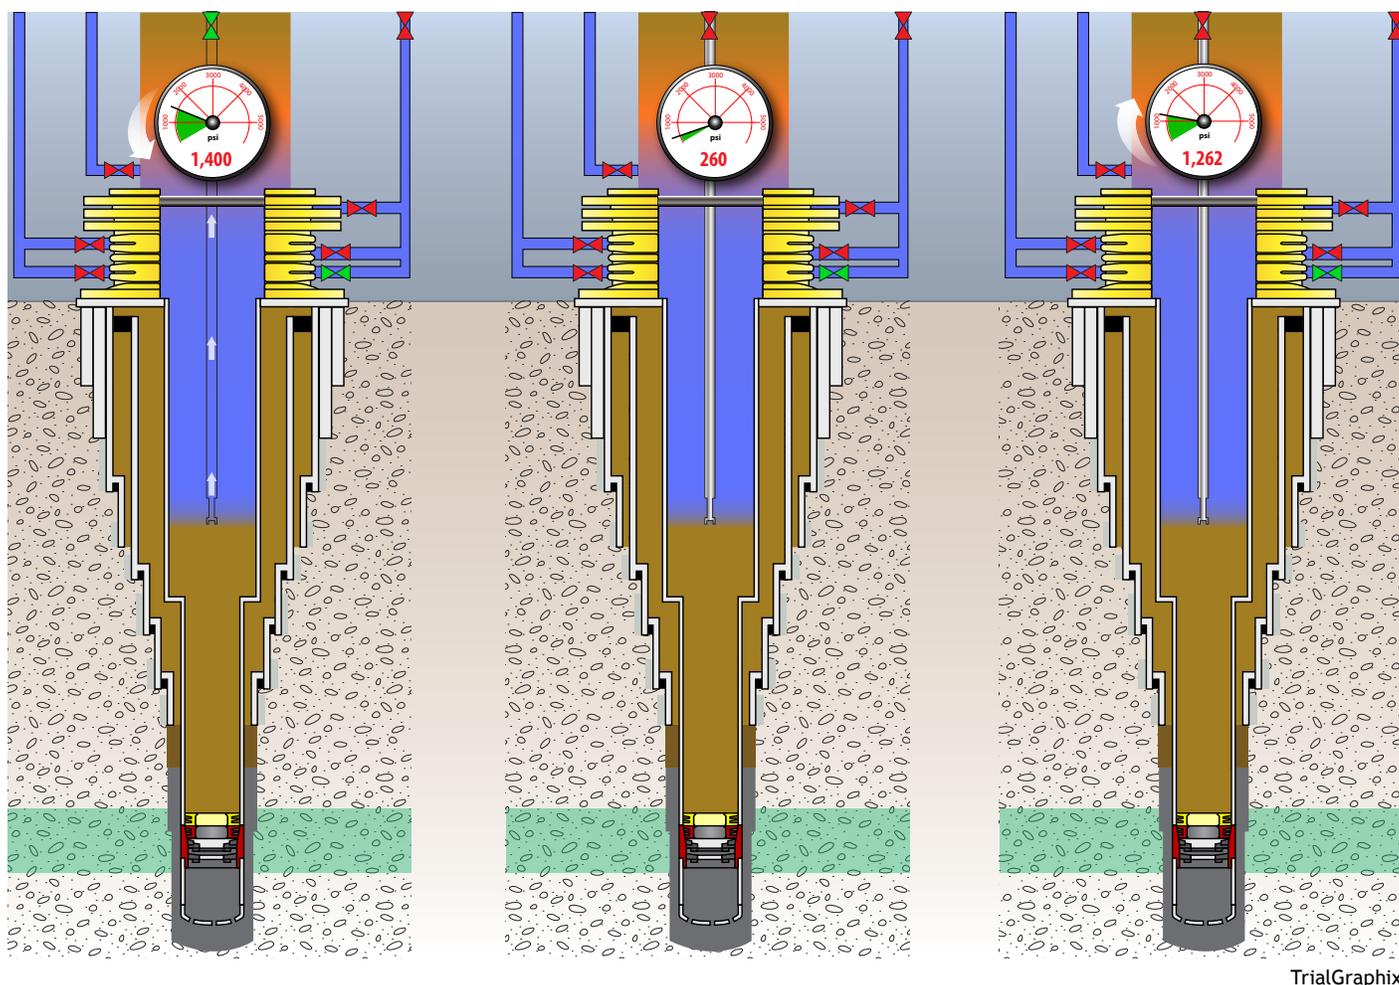
Figure 4.6.13. 4:58 p.m.

The crew began the negative pressure test by attempting to bleed the drill pipe pressure to 0 psi (left). However, the crew was unable to reduce pressure to below 260 psi (middle). This bleed returned an unknown amount of water to the rig. The crew shut in the drill pipe, and the pressure built up to 1,262 psi (right). In a successful negative pressure test, pressure does not build up.

As one independent expert has pointed out, this series of events actually constituted a failed negative pressure test, although the crew did not recognize that fact.<sup>40</sup>

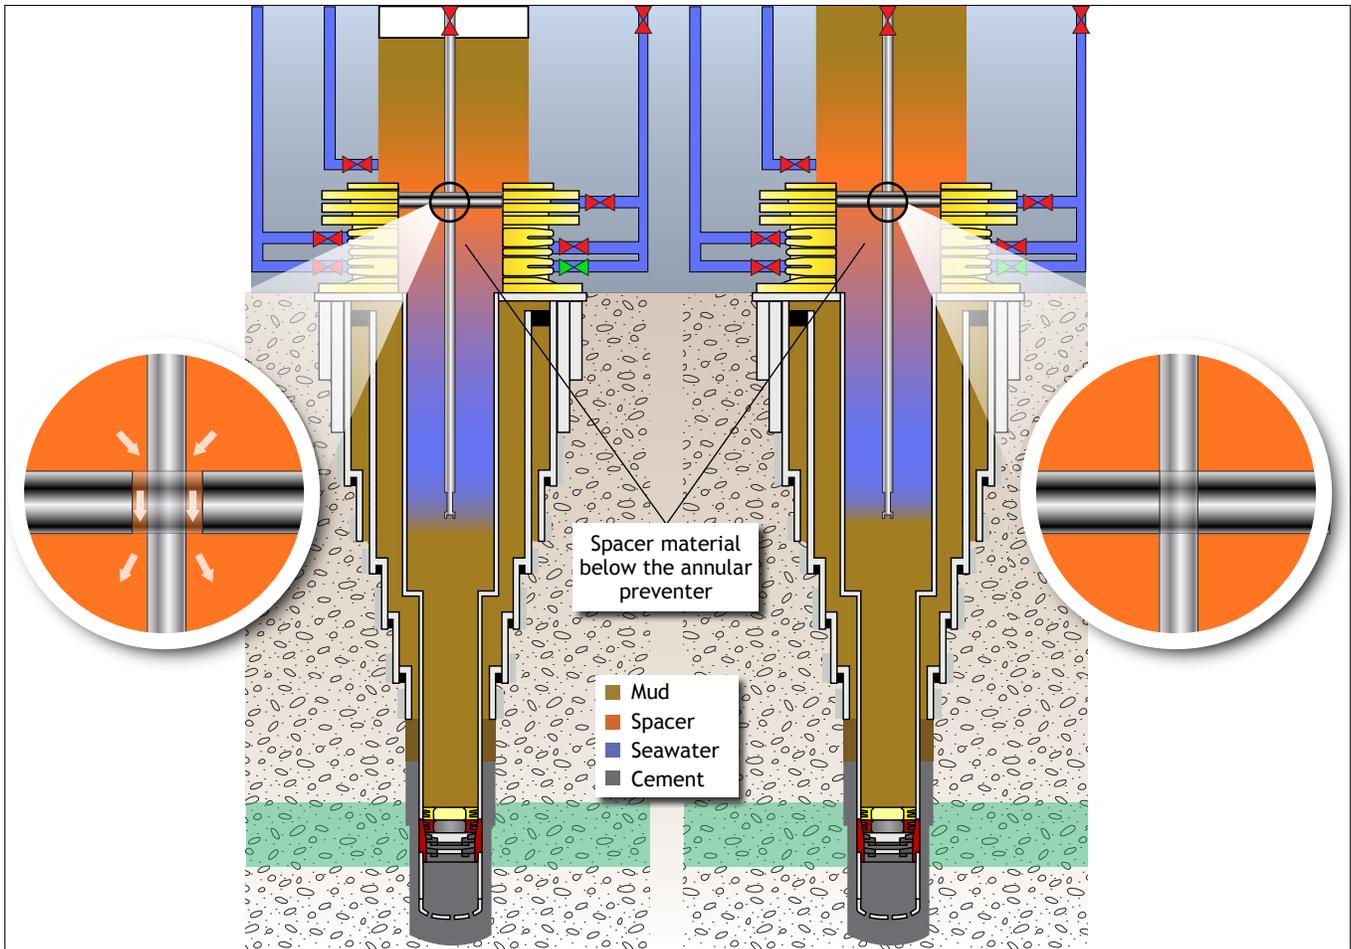
Figure 4.6.14. 5:10 p.m.

The rig crew noticed that the fluid level in the riser was falling. Because the annular preventer was not sufficiently tight around the drill pipe, spacer fell beneath the BOP (left). In response, the rig crew tightened the seal of the annular preventer and refilled the riser (right), but did not circulate the spacer back above the BOP.

At 5:10 p.m., the rig crew apparently noticed that the level of fluid in the riser was falling.<sup>41</sup> Spacer in the riser was leaking down through the annular preventer and into the well below the BOP.<sup>42</sup> Unlike many other indications, the crew could observe the fluid levels in the riser with their own eyes. When one rig crew member arrived on the rig floor, he saw others standing around the rotary table and using a flashlight to peer down into the riser to see how much fluid was missing.<sup>43</sup>

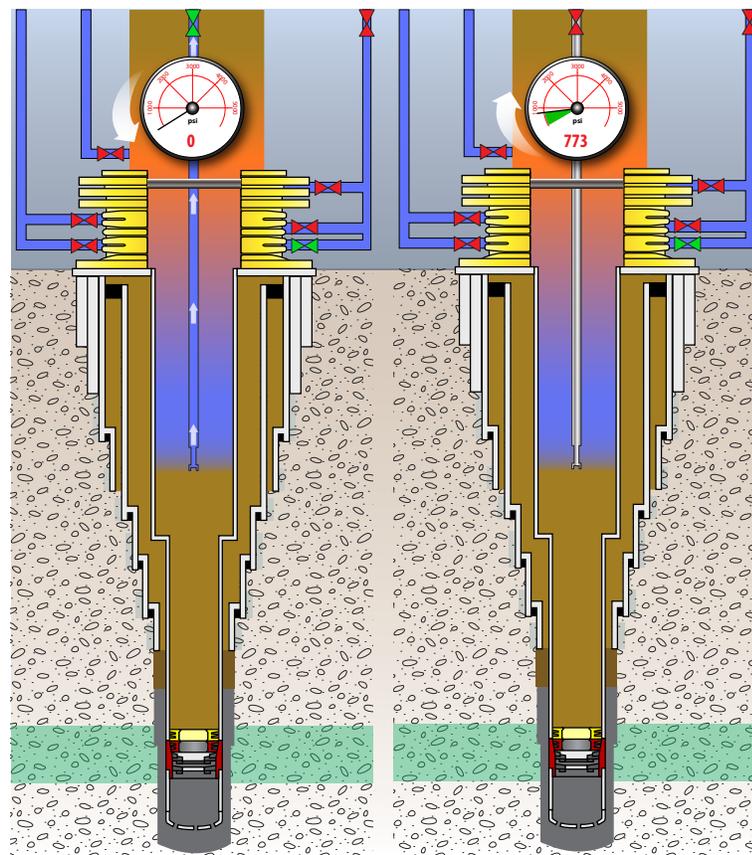
**Figure 4.6.15. 5:26 p.m.**

This second series of bleed-offs, excessive flows, and pressure buildups constituted another failed “negative pressure test” that the crew again did not recognize as such. With the annular preventer fully closed and sealed, the only explanation for the excessive returns and pressure increase would be that the primary cement job had failed to seal off the pay zone. Hydrocarbons were leaking from the formation into the well. Individuals involved in the test at this point should have recognized that the well lacked integrity.

**The rig crew attempted again, this time successfully, to bleed the drill pipe pressure down to 0 psi. Fifteen barrels of seawater were returned during this bleed (left). The drill pipe was shut in, but the drill pipe pressure rose to 773 psi. Fifteen barrels is a higher return than should have been expected, and the drill pipe pressure should not have built back up.**

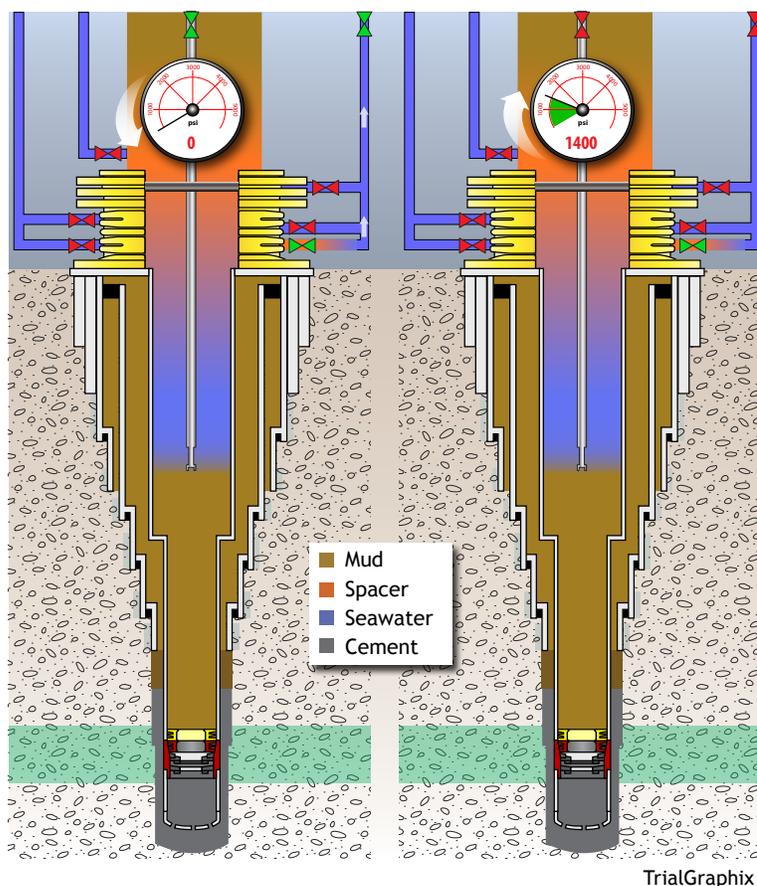
**Figure 4.6.16. 5:53 p.m.**

The rig crew bled drill pipe pressure down for a third time, this time through the kill line. Witnesses reported that three to 15 barrels were returned as the drill pipe reached 0 psi (left). When the drill pipe was shut, the drill pipe pressure rose to 1,400 psi. According to BP witnesses, the Transocean rig crew attributed this rise to a “bladder effect.” A 15-barrel return would have been excessive, and the rise of drill pipe pressure to 1,400 psi was a clear sign that the negative pressure test had failed (right).

1,400 psi pressure buildup can only have been caused by hydrocarbons leaking into the well from the reservoir formation.

One expert described this test result as a “conclusive failure.”<sup>60</sup> Later analysis has shown that 1,400 psi is approximately the reading that one would have expected reservoir hydrocarbon pressure to produce at the surface if there had been *no cement* at the bottom of the well during the negative pressure test.<sup>61</sup>

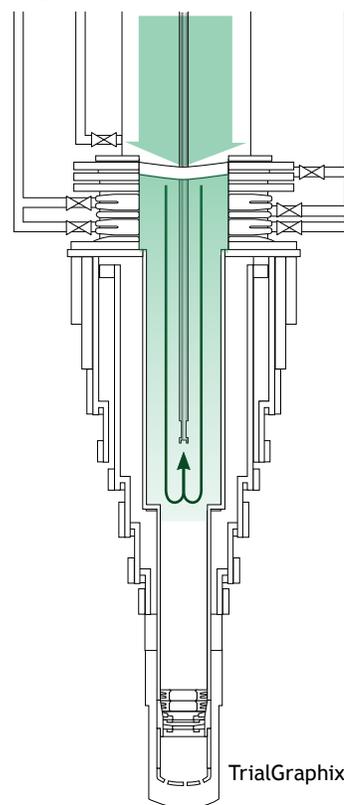
**Figure 4.6.17**

The Chief Counsel's team found no evidence to support this theory. Indeed, every industry expert that the Chief Counsel's team spoke with agreed that no such phenomenon exists. Even if it did exist, any pressure caused by this "bladder effect" would have disappeared after the rig crew bled off the drill pipe and kill line.<sup>67</sup>

**Bladder Effect.** This figure represents the Chief Counsel's team's understanding of the "bladder effect" theory that supposedly explained the elevated pressure on the drill pipe. The "bladder effect" explanation contends that heavy fluids (mud and spacer) displaced to the riser were exerting force on the annular preventer from above, which in turn communicated pressure into the well. The Chief Counsel's team found no evidence to support this theory.

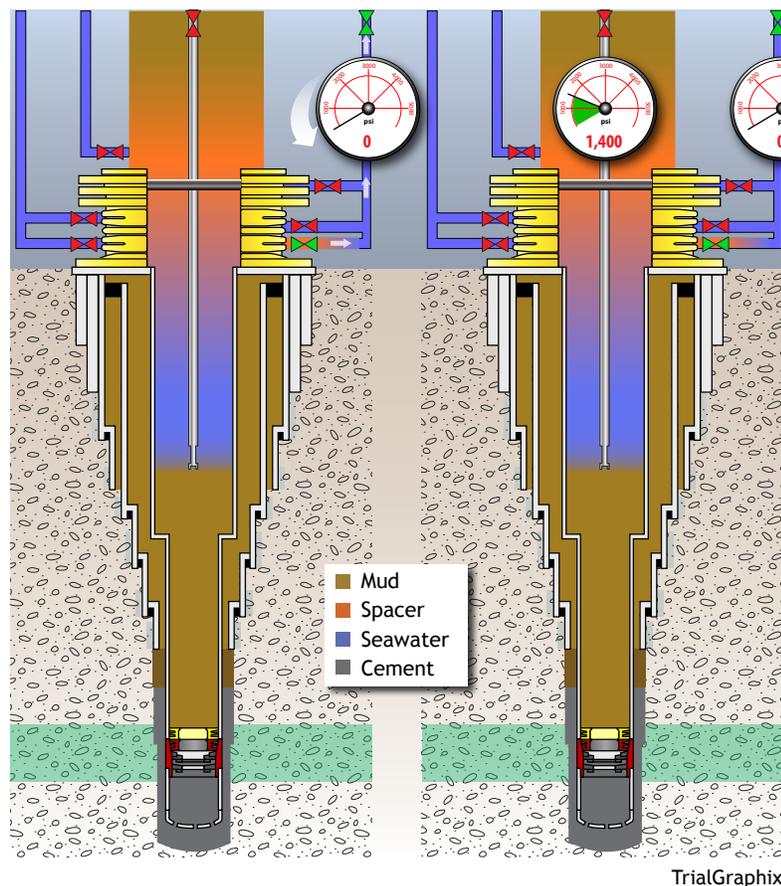
**Figure 4.6.18. 6:40 p.m.**

The rig crew conducted a negative pressure test on the kill line. The rig crew reduced the pressure on the kill line to 0 psi, bleeding an insignificant amount of water (left). No flow or pressure buildup was observed on the kill line, which on its own would have been a successful negative pressure test. However, the 1,400 psi on the drill pipe remained and was never properly accounted for (right).

The second negative pressure test showed again that the well lacked integrity. The 1,400 psi reading from the drill pipe indicated that hydrocarbons were leaking into the well. The fact that the kill line pressure was 0 psi at this time suggests that something may have been blocking fluids from flowing through the kill line and transmitting pressure to the gauges on the rig. One possibility, alluded to earlier, is that the spacer below the BOP had migrated into the 3<sup>1</sup>/<sub>16</sub>-inch

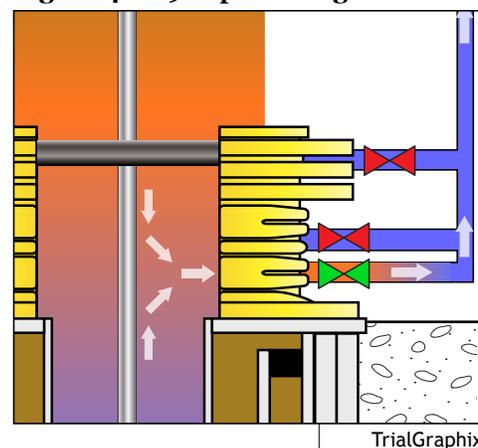
**Figure 4.6.19. Spacer migration.**

Leftover lost circulation material used as spacer for the negative pressure test could have migrated into the kill line during bleeds.

diameter kill line and clogged it.<sup>90</sup> It is also possible that rig crews accidentally closed a valve that should have been open. The kill line could also have been clogged by undisplaced mud in the kill line or by gas hydrates that solidified during the test (the same type of hydrates that complicated containment operations).<sup>91</sup> The exact reason may never be known.
