Chapter 4.8 | Kick Response

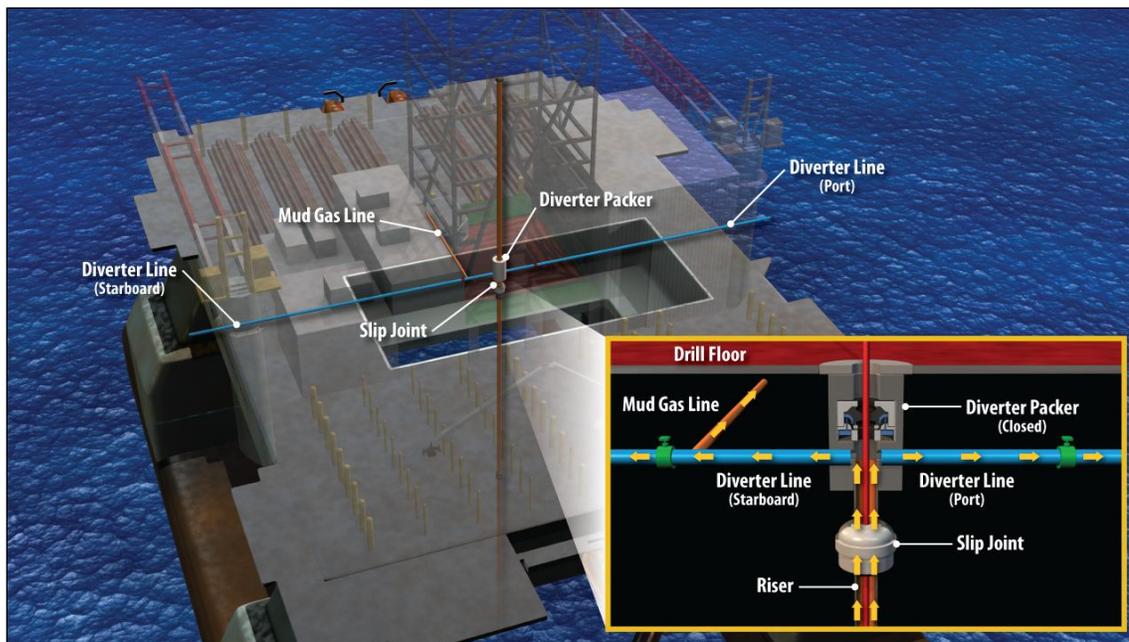
Figure 4.8.1. Diverter system.

When closed, the packer forced flow to one of two 14-inch diameter **overboard lines**—one going to the port side of the rig, the other to starboard (see Figure 4.8.1).¹⁹ The rig crew could select the direction of overboard flow in order to discharge gas on the downwind side of the rig. The starboard-side overboard line was also connected to another pipe that led to the mud gas separator. The rig crew could close a valve in the starboard line in order to route flow from that line to the mud gas separator.²⁰

On April 20, the rig crew diverted the influx to the mud gas separator rather than sending it overboard. That caused mud and gas to spray onto the rig from the derrick.

Any relief was temporary. Given the size of the influx, routing the influx to the mud gas separator rather than overboard made ignition all but inevitable. The capacity of a mud gas separator depends on the size of the outlet lines,³⁸ and these lines are generally not large enough to handle very high flow rates.³⁹ The Macondo blowout therefore quickly overwhelmed the *Deepwater Horizon’s* mud gas separator.⁴⁰ Sandell observed: “Then all the sudden the...mud started coming out of the degasser...so strong and so loud that it just filled up the whole back deck with a gassy smoke...loud enough...it’s like taking an air hose and sticking it to your ear.”⁴¹

The rig crew should have diverted the flow overboard when mud started spewing from the rig floor.⁸⁹ The flow of mud at this point was tremendous—it shot 200 feet up to the crown of the derrick. That should have prompted the crew to take immediate emergency measures.

The Chief Counsel’s team concludes that diverting flow overboard likely would have sent a substantial amount of gas off the rig.¹⁰⁷ This may not ultimately have prevented an explosion but probably would have given the rig crew more time to respond to the blowout. BP has concluded that “diversion of fluids overboard, rather than to the MGS, may have given the rig crew more time to respond and may have reduced the consequences of the accident.”¹⁰⁸ Transocean agrees that “diverting overboard might have delayed the explosion....”¹⁰⁹

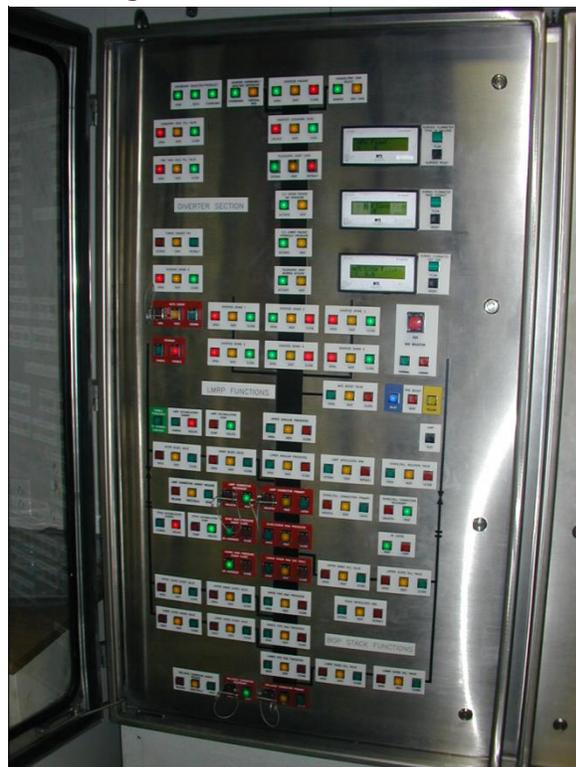
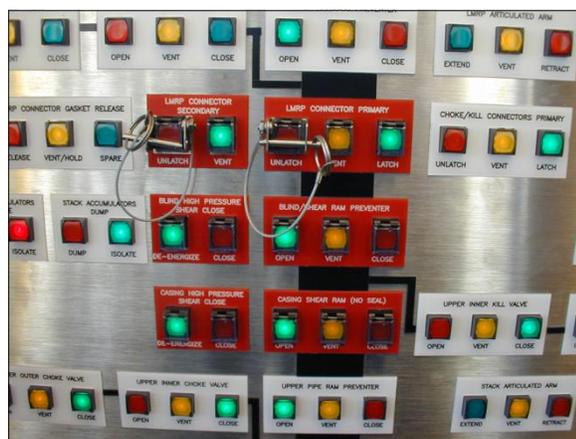
Figures 4.8.2 and 4.8.3.
BOP control panels on the rig floor and bridge.

In addition to activating the annular preventers or pipe rams, the crew could have activated the blind shear ram to cut the drill pipe and shut in the well.⁵⁴ The blind shear ram can be activated directly by the rig crew from the control panels, seen in Figures 4.8.2 and 4.8.3.⁵⁵ There is no evidence the rig crew attempted to activate the blind shear ram prior to the explosion.⁵⁶

The blind shear ram can be activated from the BOP’s control panels on the rig floor and bridge.

Captain Kuchta replied, “[c]alm down, we’re not EDSing.”⁷³ Nevertheless, with the backing of Vidrine and Transocean offshore installation manager (OIM) Jimmy Harrell, Pleasant initiated the emergency disconnect at approximately 9:56 p.m.⁷⁴ It appears that the panel’s electronic signals responded, but there was no indication of hydraulic flow closing the blind shear ram.⁷⁵ The low accumulator alarm was sounding, indicating a loss of surface hydraulic power.⁷⁶

The Chief Counsel’s team believes that by this time the explosion had already damaged the MUX cables connecting the rig and the blowout preventer, preventing the command from reaching the stack.⁷⁷ Pushing the EDS button does not appear to have activated the blind shear ram or the remainder of the emergency disconnect system. This left the rig attached to the riser. Gas continued to flow up the riser, fueling the fires on the rig.⁷⁸

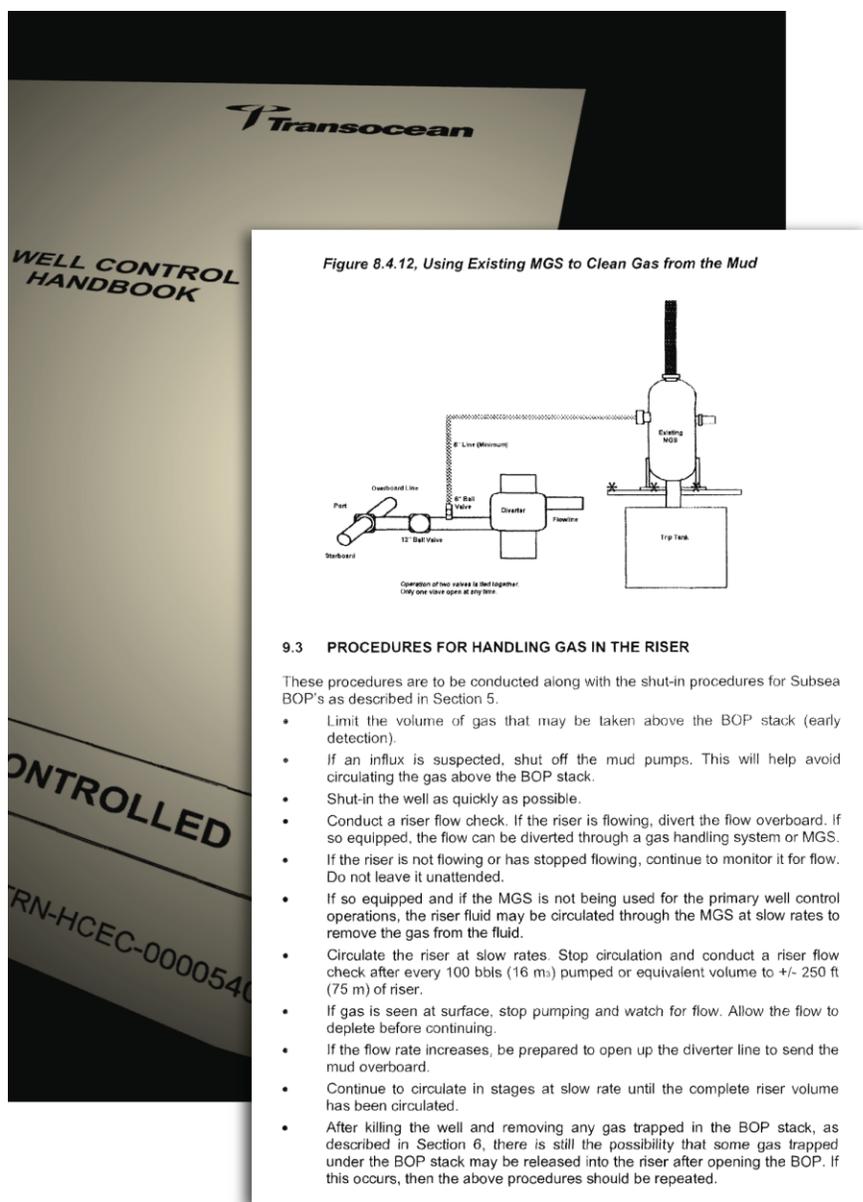
Figure 4.8.4. Transocean's “procedures for handling gas in the riser.”

Though Transocean's protocols provide that a severe influx should be sent overboard, the sequence of “procedures for handling gas in the riser”¹¹⁴ (Transocean document shown in Figure 4.8.4) specifically recommends the overboard line—instead of the mud gas separator—only in the ninth step after actions such as monitoring for flow and circulating the riser. Here, there was *no time* to get to the ninth step.¹¹⁵ In the future, well control training should include simulations and drills for low-probability, high-consequence emergency events and well-control protocols should specifically address such emergencies.¹¹⁶ ♠
