Macondo Well

Negative-Pressure Test at Macondo

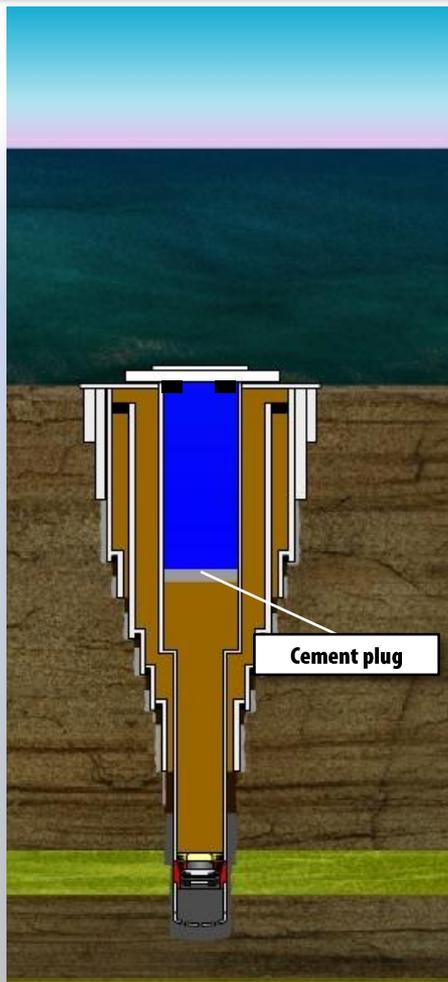
Irregularity of Setting Cement Plug So Low

A. 67, that's true. Usually it's 300 feet below the mud line, and 8367 is much further down than usual.

A. We were going to do a displacement at roughly 8,300 feet. It was a little bit – well, it was deeper than normal.

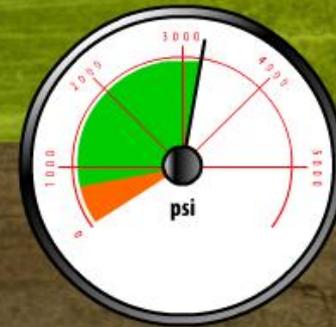
Ninth attempt to
convert float collar

Float Collar Conversion Assumed

Multiple Pay Sands
18,104' – 18,175'

Attempt(s):
