## Chapter 4.6 | Negative Pressure Test

The Chief Counsel's team finds that the failure to properly conduct and interpret the negative pressure test was a major contributing factor to the blowout.

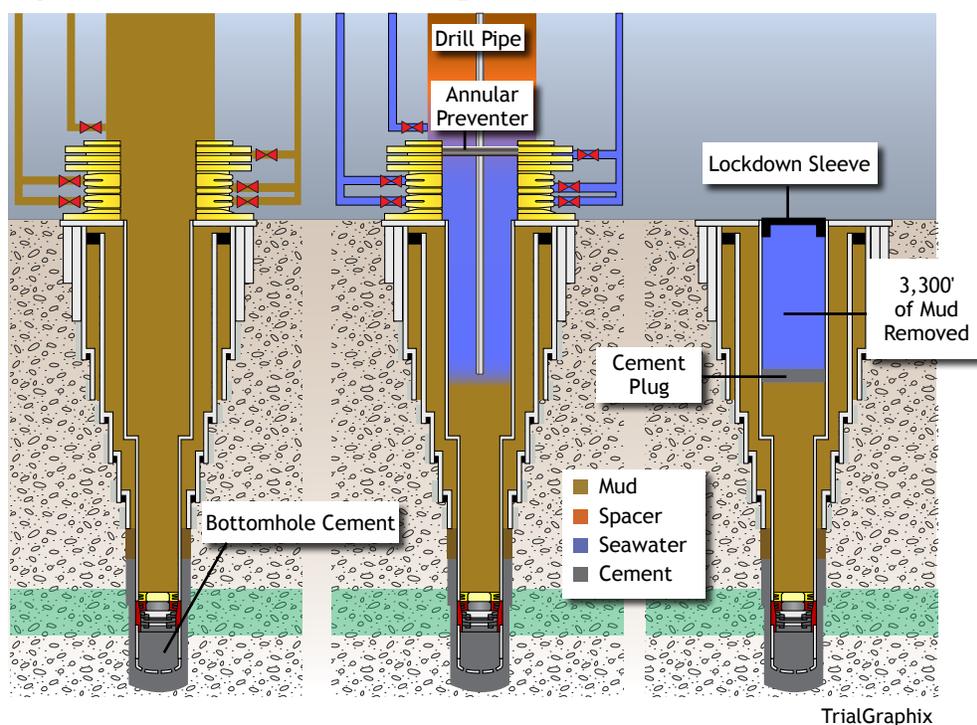
Figure 4.6.5. End of cement to temporary abandonment.

After the final casing string was cemented, heavy drilling mud filled the riser and the well (left). After the temporary abandonment planned for Macondo, the riser and its drilling mud would be removed. The drilling mud in the final casing string would be replaced with lighter seawater to a depth of over 8,000 feet below sea level (right). The removal of the hydrostatic pressure this drilling mud applied to the bottom of the well would increase the stress on the casing, seals, and cement. The negative pressure test simulated the conditions of temporary abandonment to confirm the integrity of the well in a controlled environment (middle).

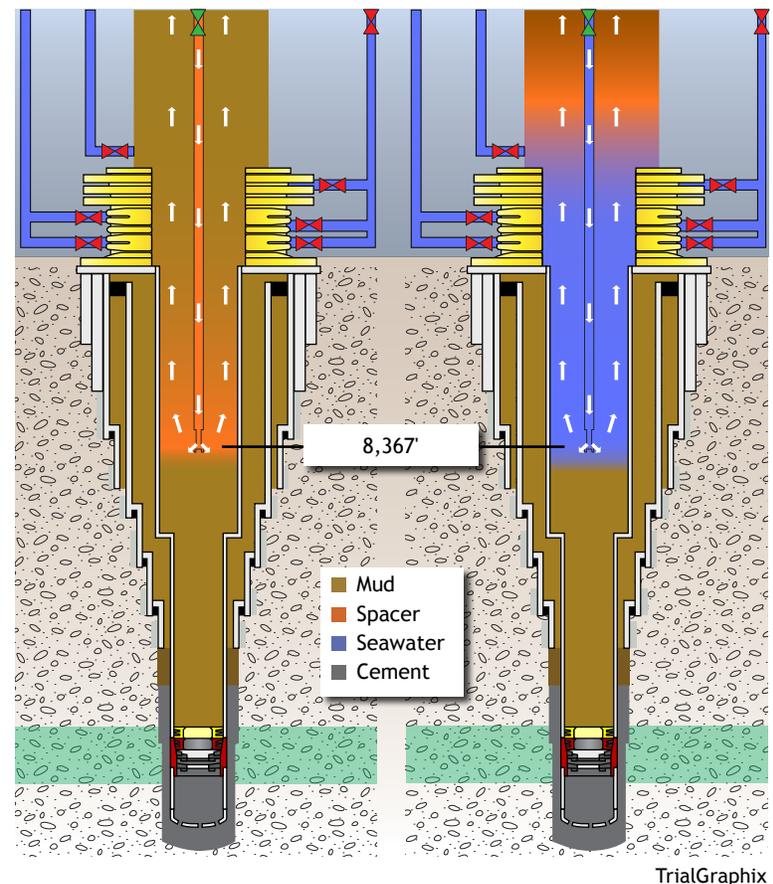
**Figure 4.6.6. Preparations for the negative pressure test.**

To prepare for the negative pressure test, the rig crew needed to displace the mud in the drill pipe and casing string from a depth of 8,367 feet to above the BOP. The crew did so by pumping spacer fluid (left) and then seawater (right) down the drill pipe until the mud was above the BOP.

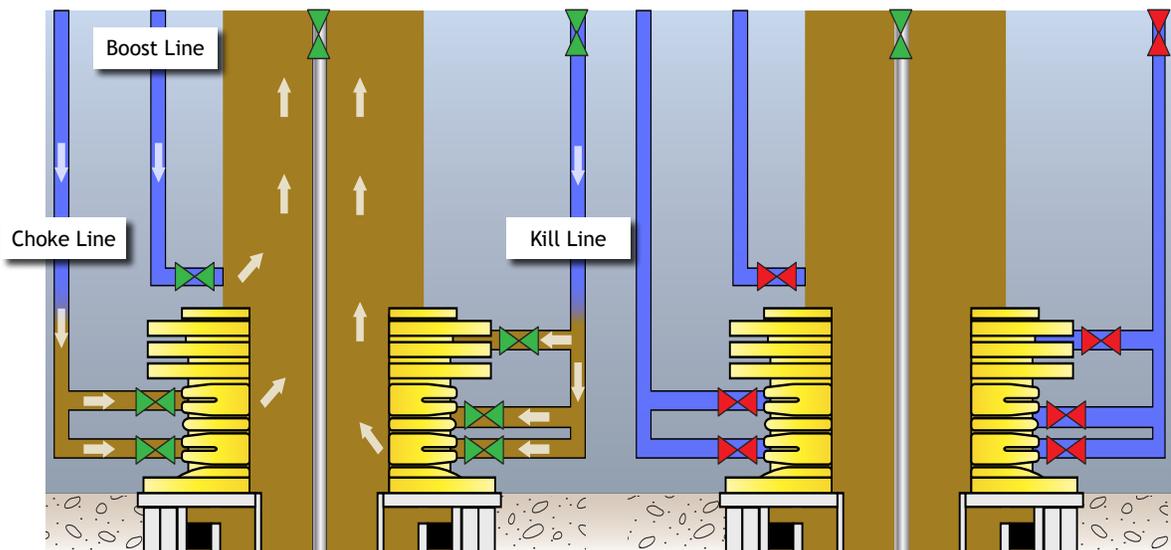
**Figure 4.6.9. Negative pressure test progress, 3 p.m. on April 20, 2010.**

To begin preparations for the negative pressure test, the rig crew displaced the boost, choke, and kill lines with seawater. Seawater was pumped into the lines on the rig, forcing mud into and up the riser (left). After the lines were displaced, the crew closed the valves connecting them to the riser and BOP (right).

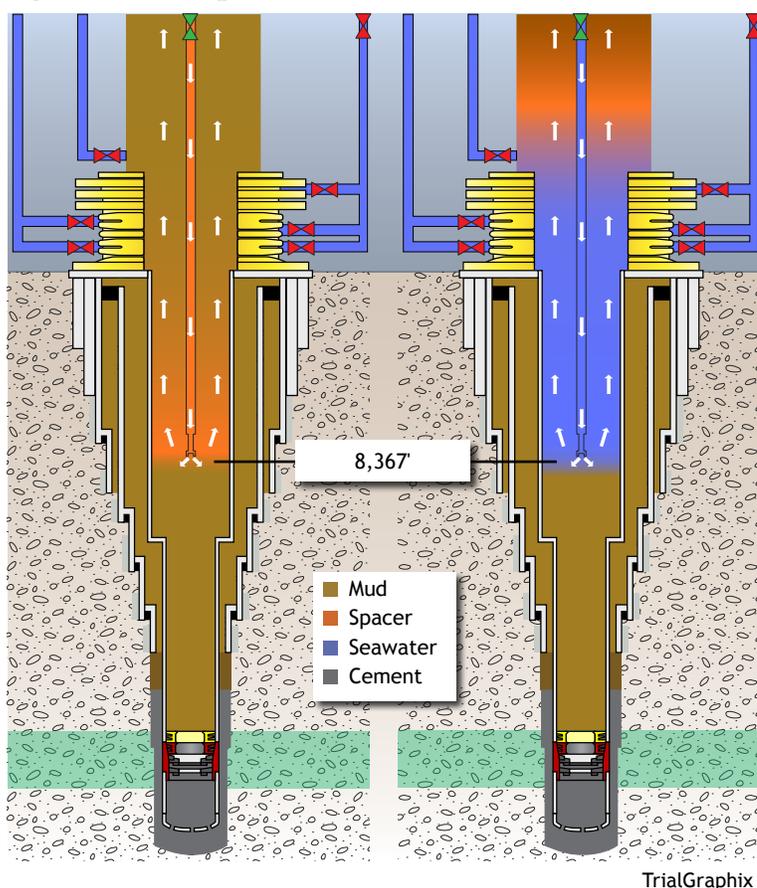
Figure 4.6.10. 4 p.m.

The crew displaced the mud in the drill pipe and in the casing from 8,367 feet to above the BOP. The crew first pumped a spacer fluid down the drill pipe, which forced the mud out and up the casing and the riser (left). Following the spacer, the crew pumped seawater into the drill pipe. This forced the spacer and the mud up the casing. The crew’s intent was to pump enough seawater to displace the spacer and mud above the BOP (right).

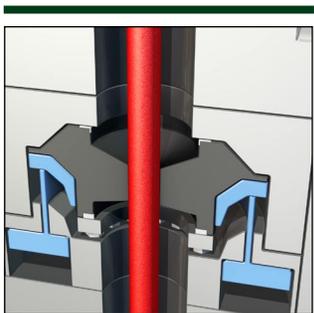
The rig crew noticed that the fluid level in the riser was falling. Because the annular preventer was not sufficiently tight around the drill pipe, spacer fell beneath the BOP (left). In response, the rig crew tightened the seal of the annular preventer and refilled the riser (right), but did not circulate the spacer back above the BOP.

At 5:10 p.m., the rig crew apparently noticed that the level of fluid in the riser was falling.<sup>41</sup> Spacer in the riser was leaking down through the annular preventer and into the well below the BOP.<sup>42</sup> Unlike many other indications, the crew could observe the fluid levels in the riser with their own eyes. When one rig crew member arrived on the rig floor, he saw others standing around the rotary table and using a flashlight to peer down into the riser to see how much fluid was missing.<sup>43</sup>

In response to the dropping levels of fluid in the riser, Harrell instructed the rig crew to tighten the seal of the annular preventer against the drill pipe as shown in Figure 4.6.14. Wyman Wheeler, the Transocean toolpusher on duty at the time, then topped off the riser with 20 to 25 barrels of mud, and the fluid level in the riser stayed steady.<sup>46</sup> The crew had thus identified and eliminated a leak in the well system that could have explained the anomalous pressure readings they had seen and their inability to bleed the drill pipe pressure to 0 psi.<sup>47</sup> By this time Kaluza returned to the rig floor.<sup>48</sup>

Despite clear evidence that spacer had probably leaked below the BOP, rig personnel again did nothing to ensure that they had fully displaced the spacer above the BOP and instead proceeded with the test.<sup>49</sup>
