Macondo Well

Negative-Pressure Test at Macondo

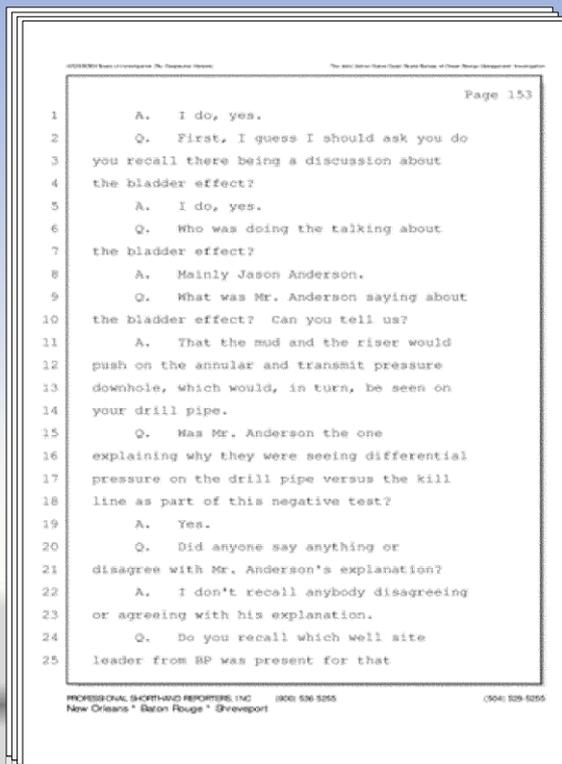
Bladder Effect?

Q. First, I guess I should ask you do you recall there being a discussion about the bladder effect?

A. I do, yes.

Q. What was Mr. Anderson saying about the bladder effect? Can you tell us?

A. That the mud and the riser would push on the annular and transmit pressure downhole, which would, in turn, be seen on your drill pipe.

Q. Did anyone say anything or disagree with Mr. Anderson's explanation?

A. I don't recall anybody disagreeing or agreeing with his explanation.

Testimony of Lee Lambert, BP Well-Site Leader Trainee, USCG 7/20 PM Tr. 153

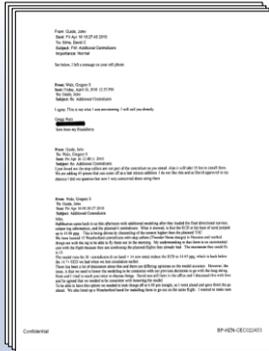
Last-Minute Decision Not to Use Additional Six Centralizers

From: Guide, John
To: Walz, Gregory S
Sent: Fri Apr 16 12:48:11 2010
Subject: Re: Additional Centralizers

I just found out the stop collars are not part of the centralizer as you stated. Also it will take 10 hrs to install them. We are adding 45 pieces that can come off as a last minute addition. I do not like this and as David approved in my absence I did not question but now I very concerned about using them
